*Int J Spine Surg* 2022, 16 (5) 899-907

# Air Crash Investigation: Pattern of Spinal Injuries, Management During the COVID-19 Pandemic, and Outcomes

**Methods:** An analysis was performed on the spinal injuries of victims of the Boeing 737 crash landing at the Karipur Airport (Calicut International Airport, Kerala, India) who were treated at a tertiary care referral hospital in August 2020. Details of the initial triage, patterns of injury, morphologies, mechanisms, management principles, and outcomes at 9 months postinjury were recorded and analyzed.

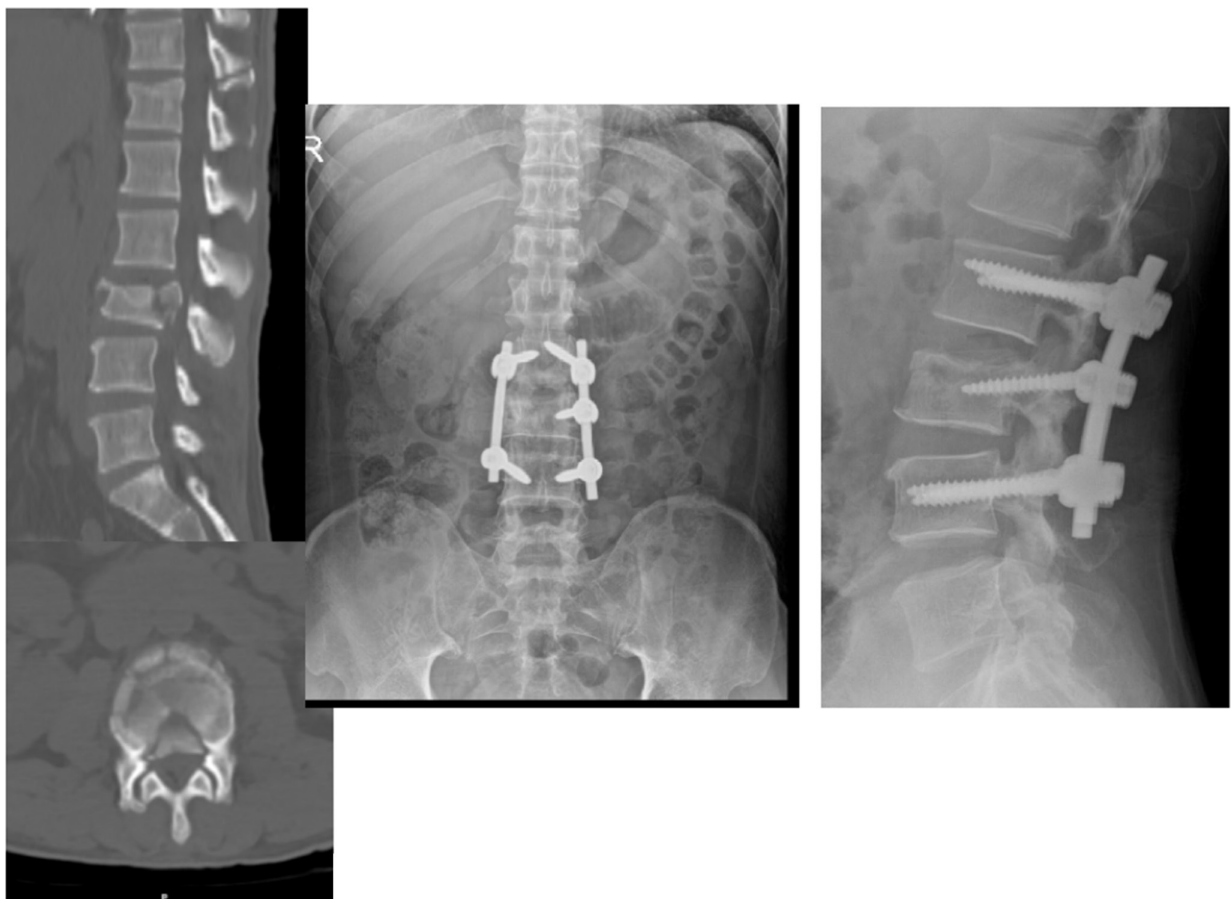
**Figure 4.** Case illustration of surgically managed patient (patient ID No. 5): 52-year-old man with L3 burst fracture, American Spinal Injury Association grade C injury. Short segment fixation with intermediate screw was performed with decompression.

5	L3 burst fracture with paraparesis, fractures of left lamina and body of C7, left transverse process of L2 and L3 and spinous process and bilateral transverse process of T11 (Figure 4)	A4	L2-L4 stabilization and decompression	Day 2	31	ASIA grade C	ASIA grade D	Walks with support, not able to climb stairs, not able to do job
6	L3 chance fracture with burn injury over the back, L1-L4 spinous process fracture	B1	L2-L4 stabilization and decompression	Day 3	75	ASIA grade E	ASIA grade E	Mobilization out of bed starting with walker, functionally dependent
7	T3 chance fracture	B1	Advised to have surgery but refused, managed conservatively	-	4	ASIA grade E	ASIA grade E	Able to do all activities, mild back pain on prolonged activities
8	Fracture T3 vertebral body, fracture spinous process of T1, T2	A3	Conservative	-	6	ASIA grade E	ASIA grade E	Able to do all activities, back pain during prolonged standing

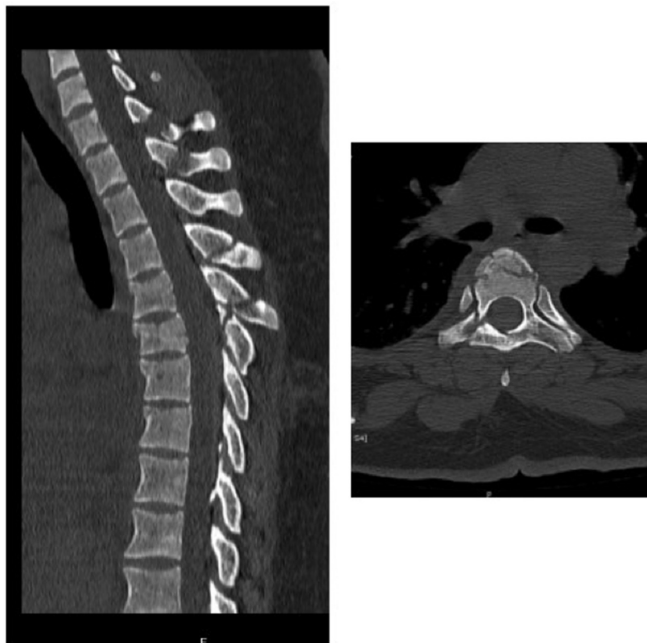
**Figure 5.** Case illustration of conservatively managed patient (patient ID No. 9 in Table 1): 24-year-old woman with multilevel dorsal level compression fractures with injuries of spinous processes, American Spinal Injury Association grade E.

9	Compression fracture T3, T4, T5, T6, and T7, spinous process fracture C7, T1, T2, T5, and T6 (Figure 5)	B1	Conservative	-	6	ASIA grade E	ASIA grade E	Mild back pain while lifting weight
10	T12 superior endplate impacted compression fracture	A1	Conservative	-	8	ASIA grade E	ASIA grade E	Able to do all activities, returned to work
11	Fracture right transverse process of L5	A1	Conservative	-	5	ASIA grade E	ASIA grade E	Able to do all activities, returned to work
12	Contusion cervical spine, traumatic upper trunk brachial plexopathy (C5, C6)	-	Conservative physiotherapy	-	18	Left shoulder abduction grade 0/5, grip strength weak	Good motor recovery	On physiotherapy, difficulty in lifting object with left upper limb
13	L5 vertebrae body burst fracture	A3	Conservative	-	21	ASIA grade E	ASIA grade E	Started walking with support, not able to do job
